SenoBright

Contrast Enhanced Mammography

Available at Moore County Hospital District

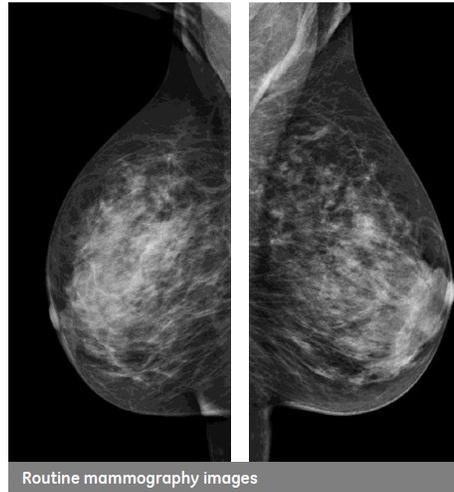
Routine mammography images

In a routine mammogram, a nodular lesion with undefined borders was identified at the right midline upper breast. A follow up ultrasound showed a solid nodule with well-defined borders (associated with calcifications.)

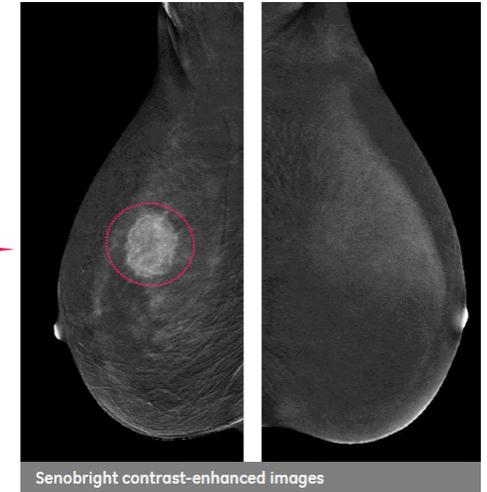
Senobright contrast-enhanced images

The SenoBright images show a suspicious area (nodule) on the right breast. A biopsy proved it was invasive ductal carcinoma.

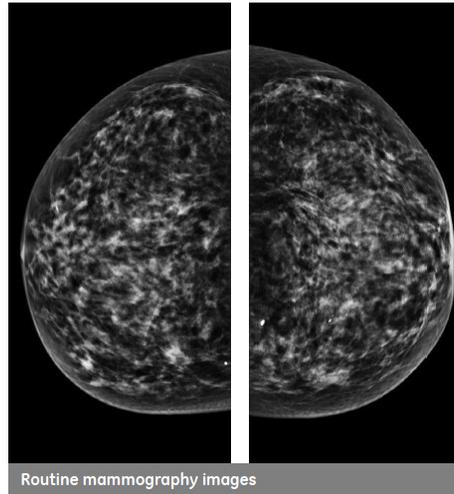
Routine mammography images

In standard mammography images (MLO view) in very dense and heterogeneous breasts, a suspected mass was visible in the right inner quadrant.

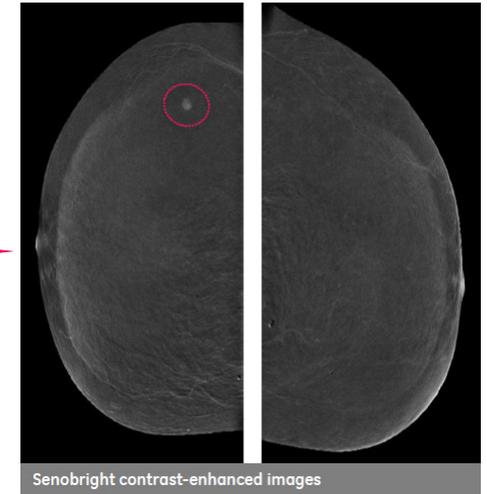
Senobright contrast-enhanced images

The highlighted area did not match the suspected mass that was detected on the routine image. The SenoBright images showed a suspicious area in the right upper quadrant, which a biopsy proved to be invasive ductal carcinoma.
